AIRCRAFT ACCIDENT REPORT

CRASH DURING LANDING
FEDERAL EXPRESS, INC.
MCDONNELL DOUGLAS MD-11, N611FE
NEWARK INTERNATIONAL AIRPORT
NEWARK, NEW JERSEY
JULY 31, 1997

NTSB/AAR-00/02

DCA97MA055

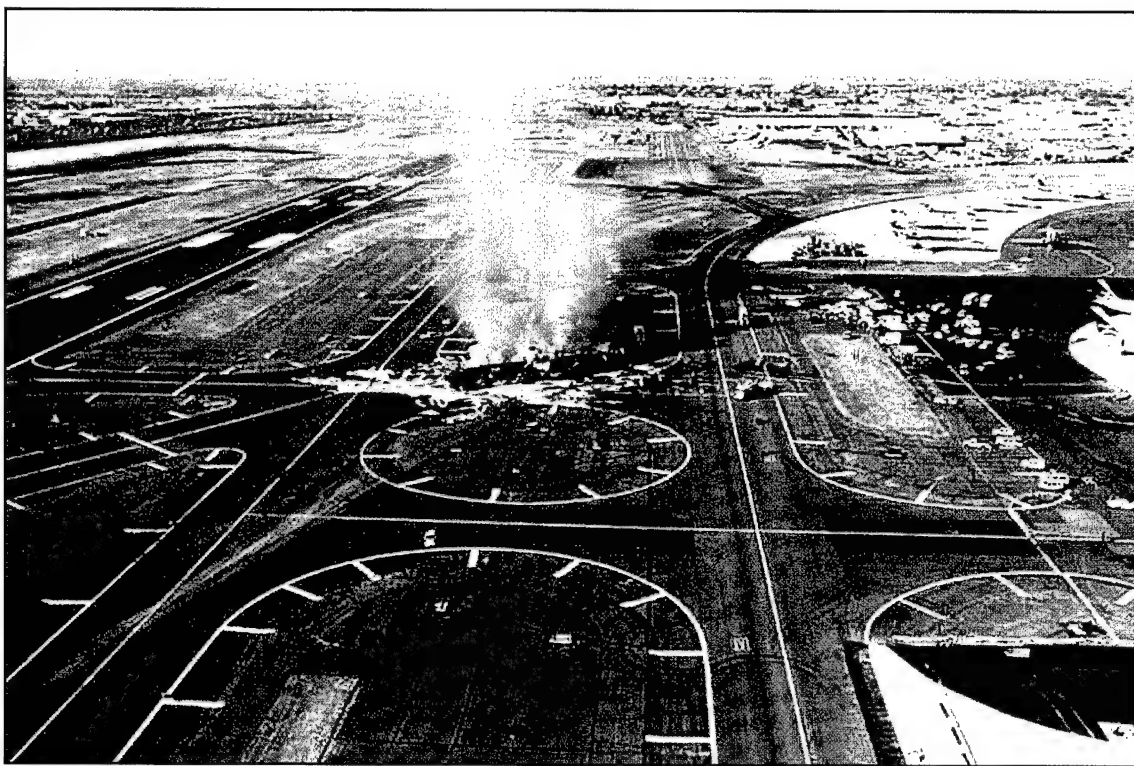
Figure 1. Aerial view of the accident site.

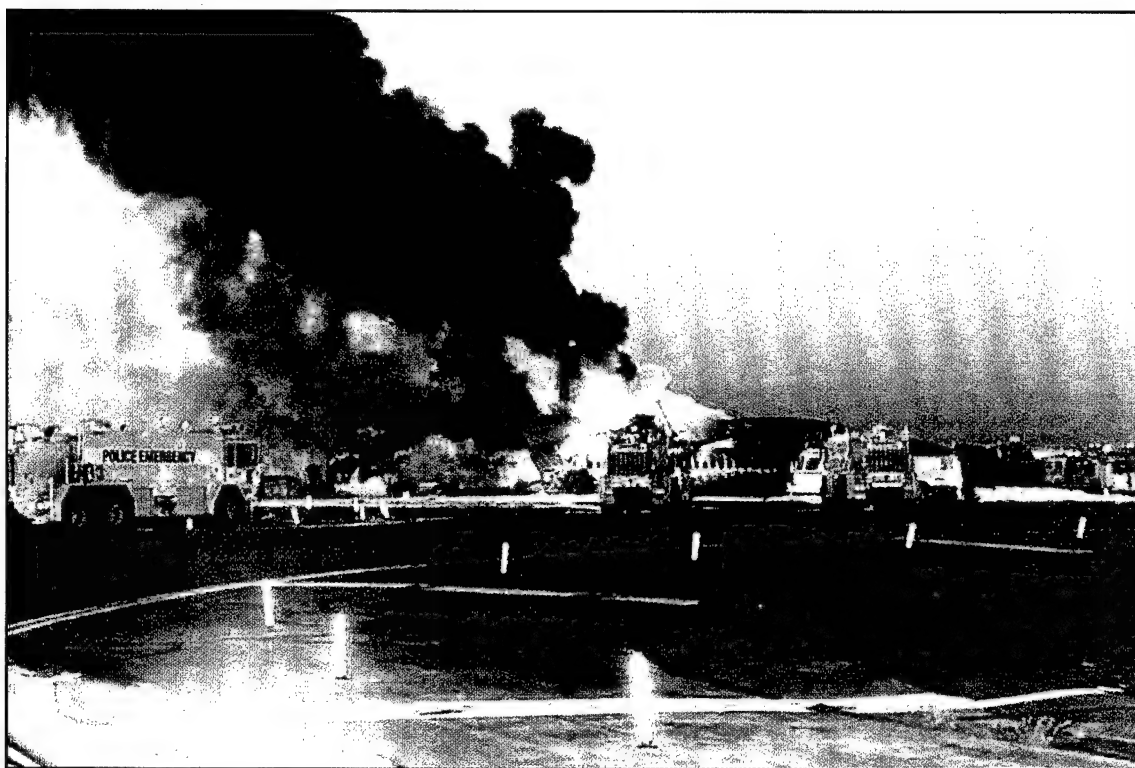
Figure 2. N611FE at the height of the firefighting effort.

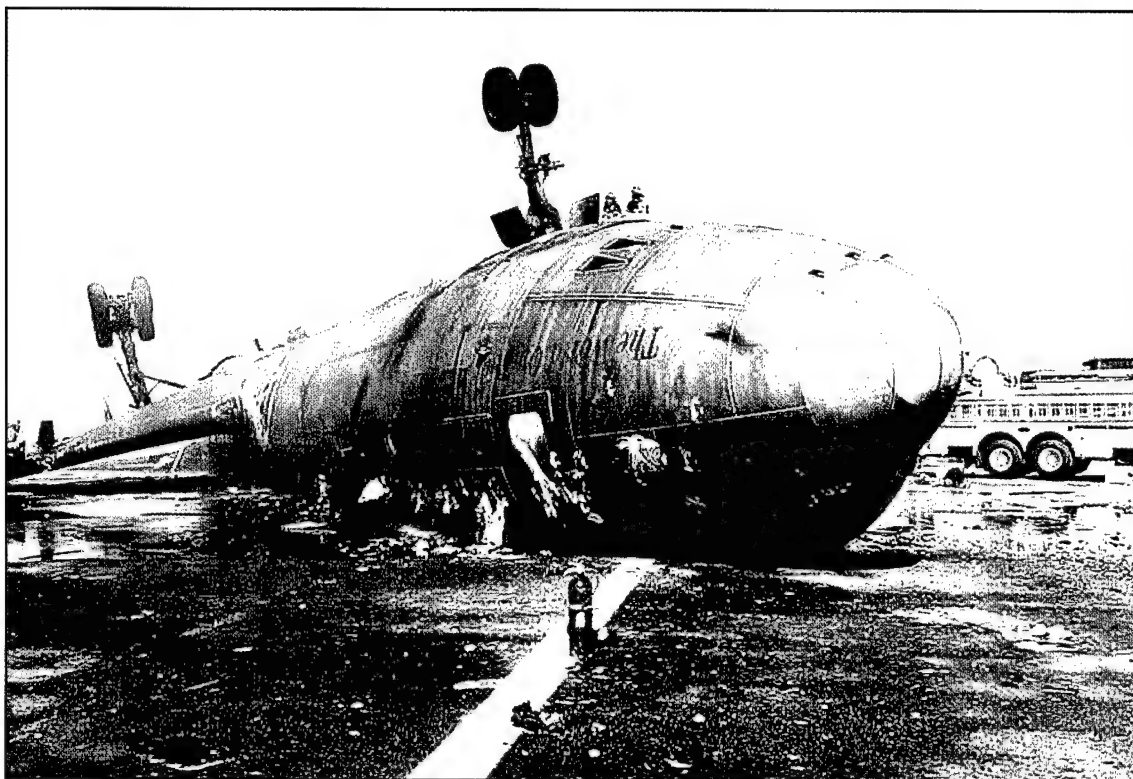
Figure 4. N611FE after the fire was extinguished.

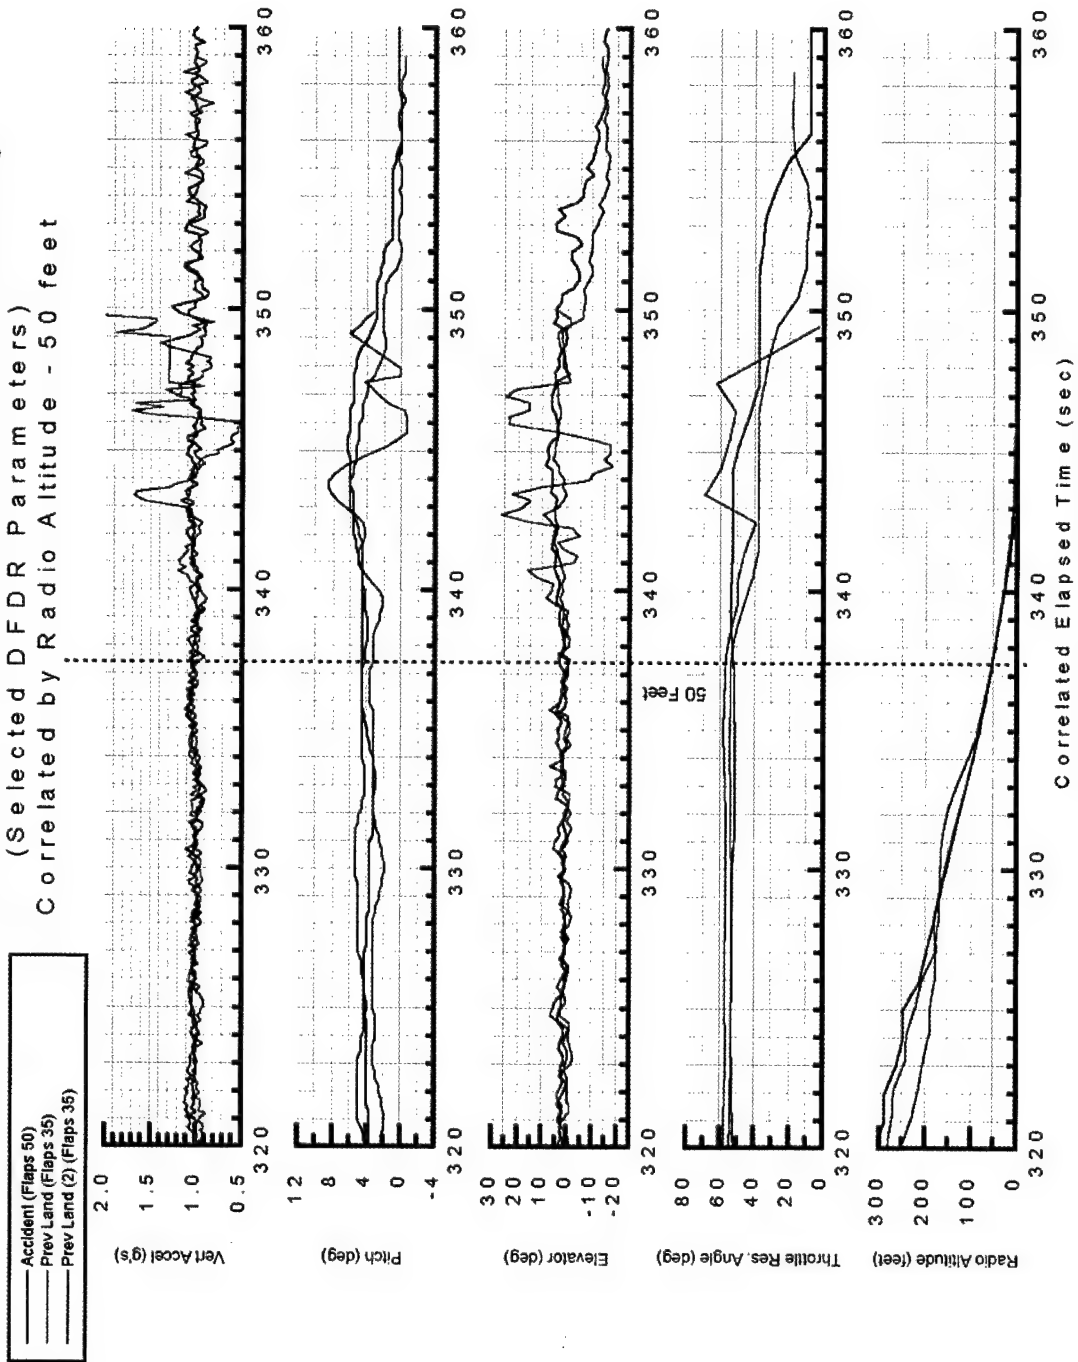
Figure 5. Comparison of selected DFDR parameters for accident landing and previous two landings (correlated by radio altitude - 50 feet).

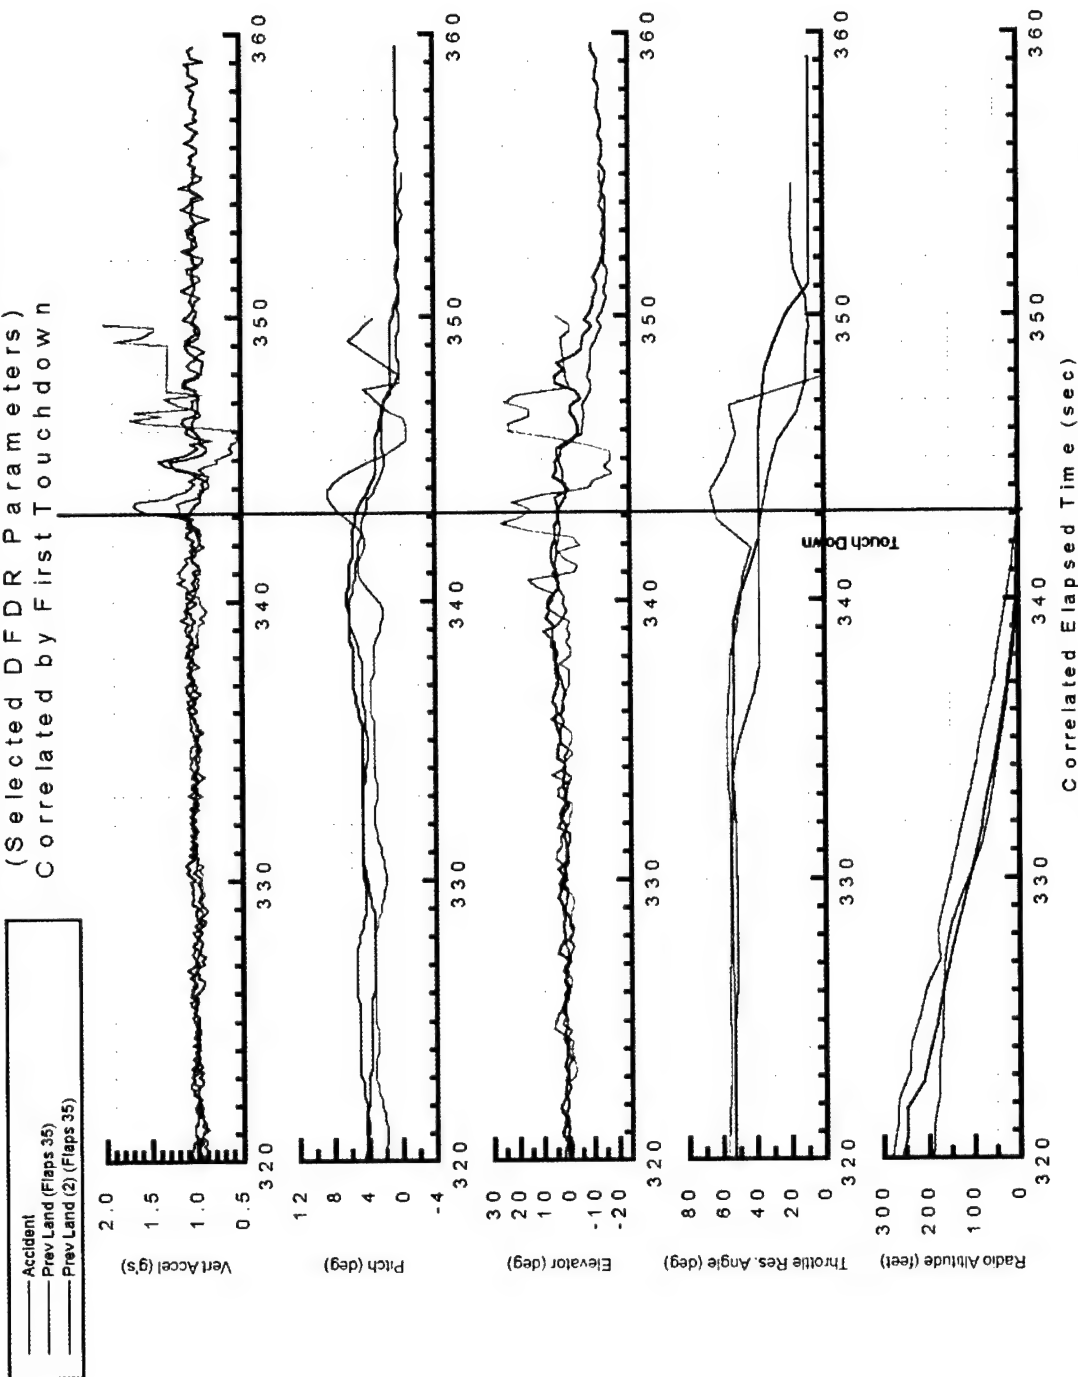
Figure 6. Comparison of selected DFDR parameters for accident landing and previous two landings (correlated by first touchdown).

As the airplane touched down at 0132:18.6, pitch attitude and vertical acceleration were increasing (along with engine speeds). It touched down 1,126 feet beyond the runway displaced threshold with a 7° nose-up pitch attitude. Vertical speed at the time of the first touchdown was about 7.6 feet per second (fps).²³ Vertical acceleration peaked at 1.67 g. About 1/2 second after the first touchdown, the FDR recorded an 18° AND elevator deflection (maximum possible MD-11 AND elevator deflection is 27°) and a TRA decrease.²⁴ At 0132:19, rudder deflection decreased to near zero, and the magnetic heading stabilized at 217.4° (the published magnetic heading for the runway was 219°). Pitch attitude peaked at 8.44° and began decreasing. Thrust continued to increase with N_1 values of about 65 percent. Airspeed began to increase and the airplane became airborne.²⁵

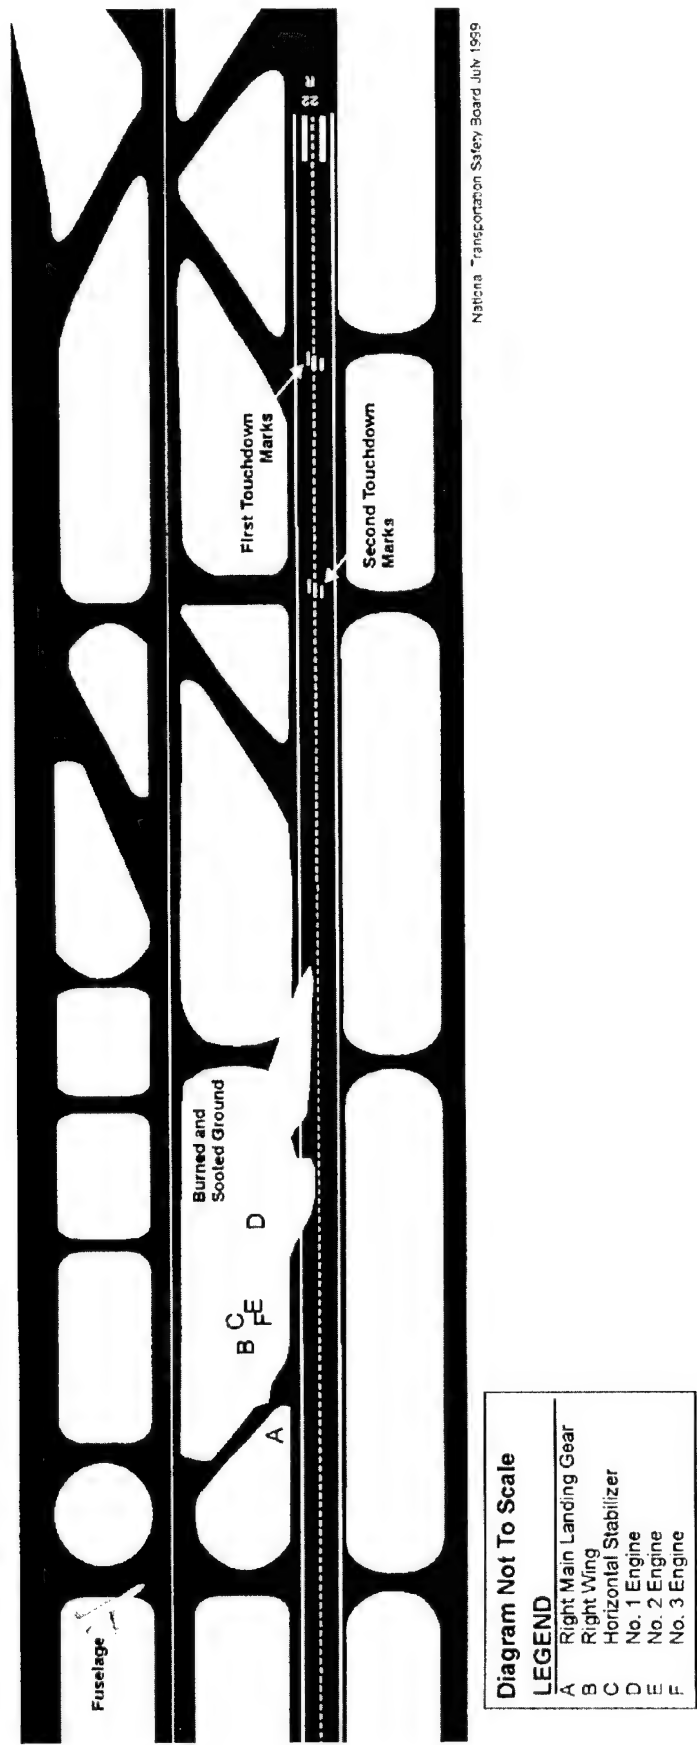
Figure 7. Wreckage distribution diagram.

The airplane's wreckage was distributed along a 2,900-foot-long debris path that gradually arced to the right across runway 22R (see figure 7). Pieces of the right inboard trailing edge flap were found at the beginning of the wreckage path, about 2,226 feet from the runway's displaced threshold. The main wreckage, located about 5,126 feet from the runway threshold and 580 feet to the right of the runway centerline, comprised the fuselage, left wing, nose gear, left MLG, center MLG, and horizontal stabilizer. The fuselage came to rest inverted with the nose on a 95° heading. Other airplane components and structure separated from the airplane during the crash sequence and were located along the debris path.

Rubber marks consistent with the touchdown of the airplane's right MLG tires were found about 1,126 feet from the runway displaced threshold. Rubber marks consistent with the touchdown of the left MLG tires and center MLG tires were found at 1,151 feet and 1,160 feet from the runway displaced threshold, respectively. The location of the tire marks was consistent with a touchdown near the center of the runway. Rubber marks consistent with a second touchdown of the right MLG tires were found about 1,924 feet from the runway displaced threshold (798 feet after the tire marks consistent with the first touchdown). Rubber marks consistent with the center MLG tires were found again about 1,983 feet from the runway displaced threshold. The locations of the second touchdown tire marks were consistent with a touchdown near the center of the runway. The right MLG tire rubber marks veer to the right about 1,995 feet from the runway displaced threshold.

Ground scarring consistent with the No. 3 (right) engine nacelle contacting the runway were found about 2,164 feet from the runway displaced threshold and continued to about 3,476 feet from the runway threshold. Runway scarring consistent with impact of the right inboard trailing edge flap was found about 2,299 feet from the runway threshold, ending about 2,376 feet from the threshold (where the right inboard trailing edge flap was found). Soot marks consistent with burning fuel were found about 2,506 feet from the threshold and continued to the end of the wreckage path. Runway scrape marks and purple paint⁴² consistent with the airplane's tail striking the runway were found about 2,644 feet from the runway threshold and ended about 3,060 feet from the threshold. About 2,826 feet from the threshold, runway scrapes, soot marks, and runway surface gouging began turning toward the right of the runway.

The right wing, the vertical stabilizer, and all three engines separated from the airplane and were found in a grassy area to the right of the runway, about 4,577 feet from the runway threshold, and had sustained fire damage consistent with a postaccident fuel fire. The right MLG strut assembly and two MLG wheels and tires were found on the right edge of the runway, about 4,805 feet from the runway threshold. The other two right MLG wheels and tires were found about 235 feet to the right of the runway centerline and about 4,957 feet from the threshold.

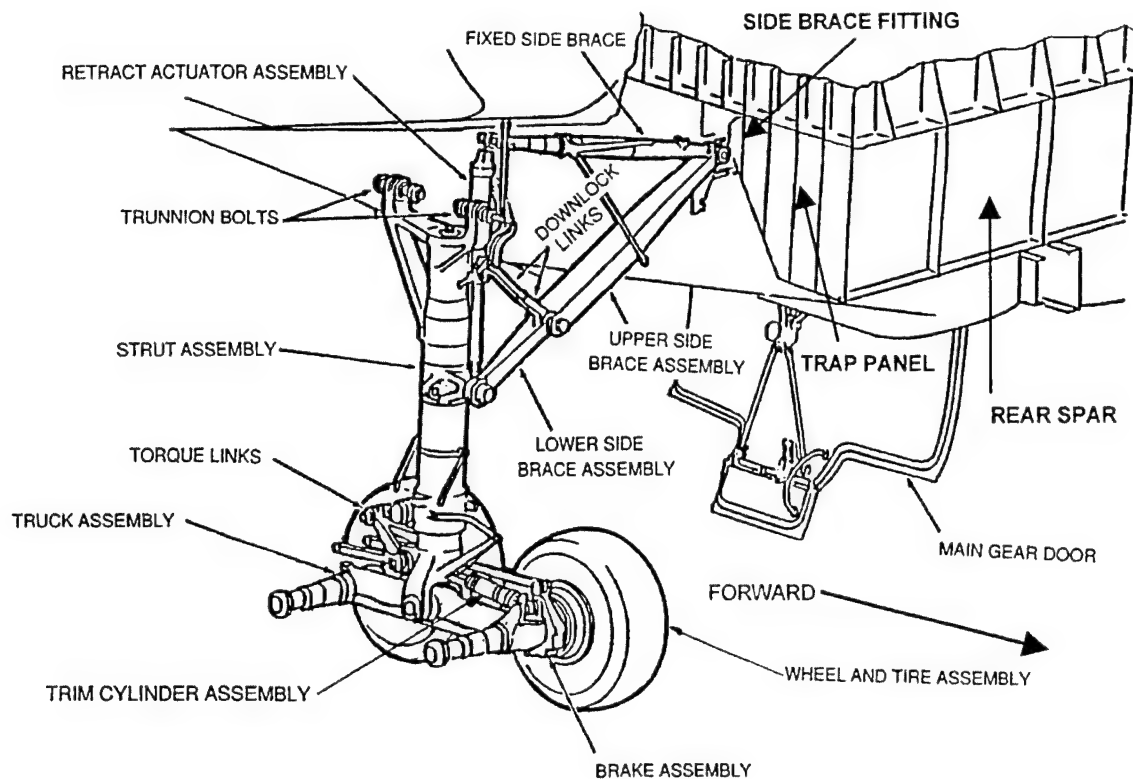
The right MLG was separated from its attach points on the right wing (see figure 8).⁴³ The attach points were broken from the wing, except for the forward lug, which remained attached to the wing with no evidence of failure. The right MLG truck assembly⁴⁴ was found separated into four parts: one part was attached to the aft axle, where the wheels and tires were found intact; a second part was found on the runway; a

Figure 8. Right MLG components.

third part was found attached to the forward axle, where the No. 3 and No. 4 wheels were found intact; and a fourth part was found attached to the strut assembly. The pivot pin was found intact between the truck beam and the oleo piston assembly. The oleo piston and cylinder were found intact, and the piston was fully extended. The torque links were intact and had no structural damage. Parts of a wing-to-gear fitting were found on the aft trunnion⁴⁵ bolt. The forward trunnion bolt, or fuse pin,⁴⁶ failed and had broken into two pieces along the shear plane.⁴⁷ The aft portion of the forward trunnion bolt was found on the runway, and the forward portion was found in the right wing-to-gear-fitting forward trunnion lug.

Scraping damage was found on the forward trunnion lug's forward face. The fixed side brace (to) folding side brace fitting joint was found intact with the side brace, the fixed brace, the side brace fitting (commonly referred to as the "pillow block"), and the pillow block hinge joint pin assembly (see figure 8). The inboard attach bolt was found intact with the pillow block and a part of the trapezoidal panel assembly. The remaining bolt was found detached and in two pieces. One piece was found in the remaining part of

the trapezoidal panel that had broken off from the fuselage and the pillow block assembly. The other bolt piece was found on the runway. The fixed side brace was found fractured about 6 inches from the wing fitting lug and was bent in the aft direction where it failed.

A metallurgical examination of the recovered right MLG components determined that all fracture surface evidence was consistent with overload failure. No evidence of fatigue cracking or corrosion was found. In addition, the examination found no indications of preimpact failures or anomalies. An examination of the right MLG tires found no evidence of pretouchdown failures or malfunctions.

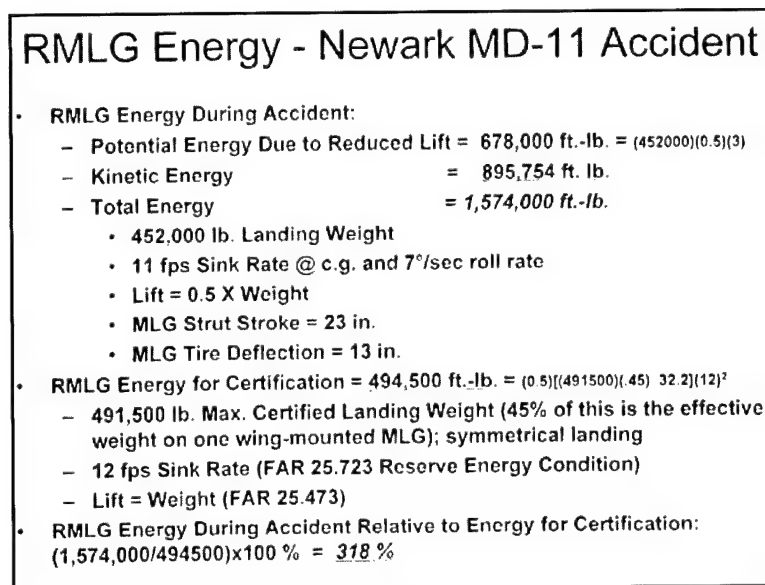
Figure 9 shows Boeing's calculations of the energy imparted to the right MLG in the Newark accident.

Figure 9. Boeing calculations of right MLG energy in the Newark accident.

The Boeing submission concluded that a “sink rate of approximately 13.5 fps (11 fps at the [c.g.] plus the [right-wing-down] roll rate) at touchdown impact is, by itself, outside the design envelope; a 13.5 fps sink rate landing on a single [MLG] is even further outside the design envelope; [and] a 13.5 fps sink rate landing on a single [MLG] with a net 0.5 g downward acceleration is yet further outside the design envelope.”⁵⁹
